## **B. Description of Work Accomplished**

### Cessna Skymaster N2362S S/N 337-0662 Mitchell Engine Gauge Cluster Wiring Diagram

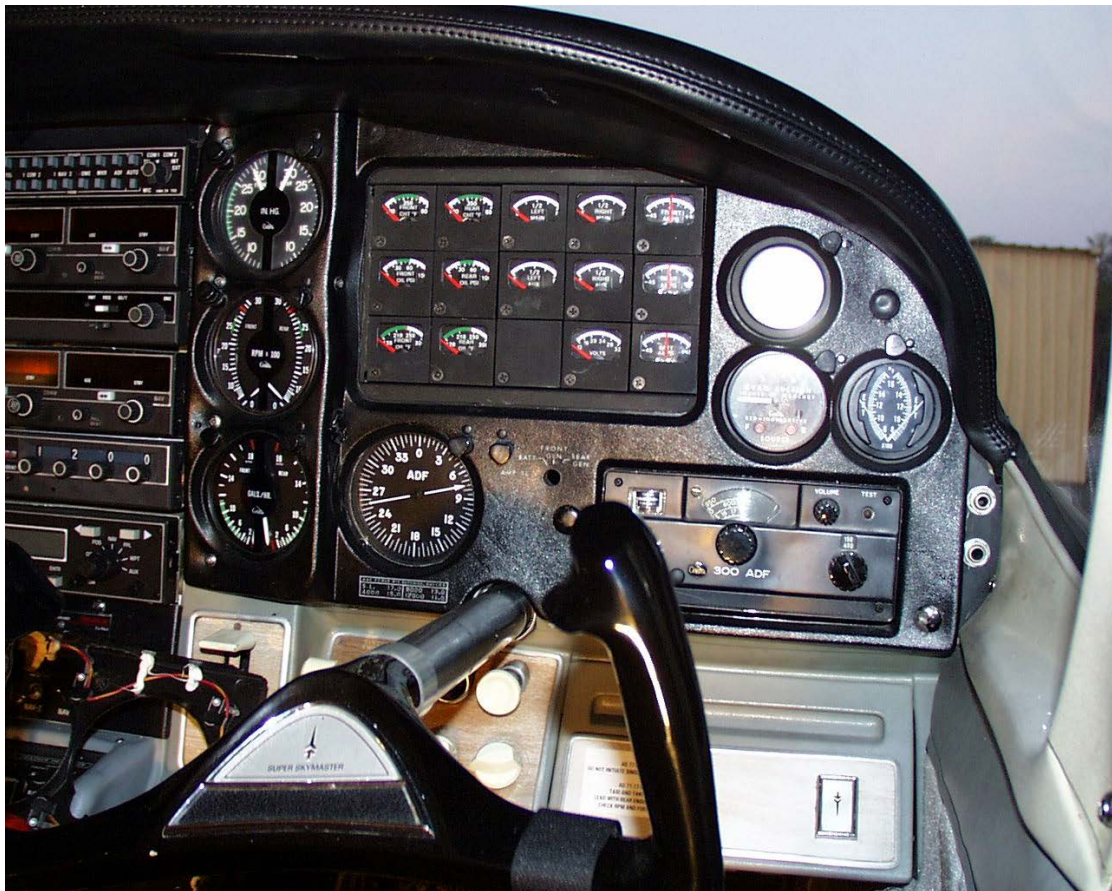
Figure 1 – Mitchell Replacement Engine Gauge Cluster

1. Removed original Cessna instrument cluster p/n P443-12-RAND-500-5/70 and checked weight, 2.0lbs.
2. Weighed replacement Mitchell instrument cluster, p/n PM-211-6835, with all gauges and wiring pigtail in place, 5.2 lbs. See figure 1.

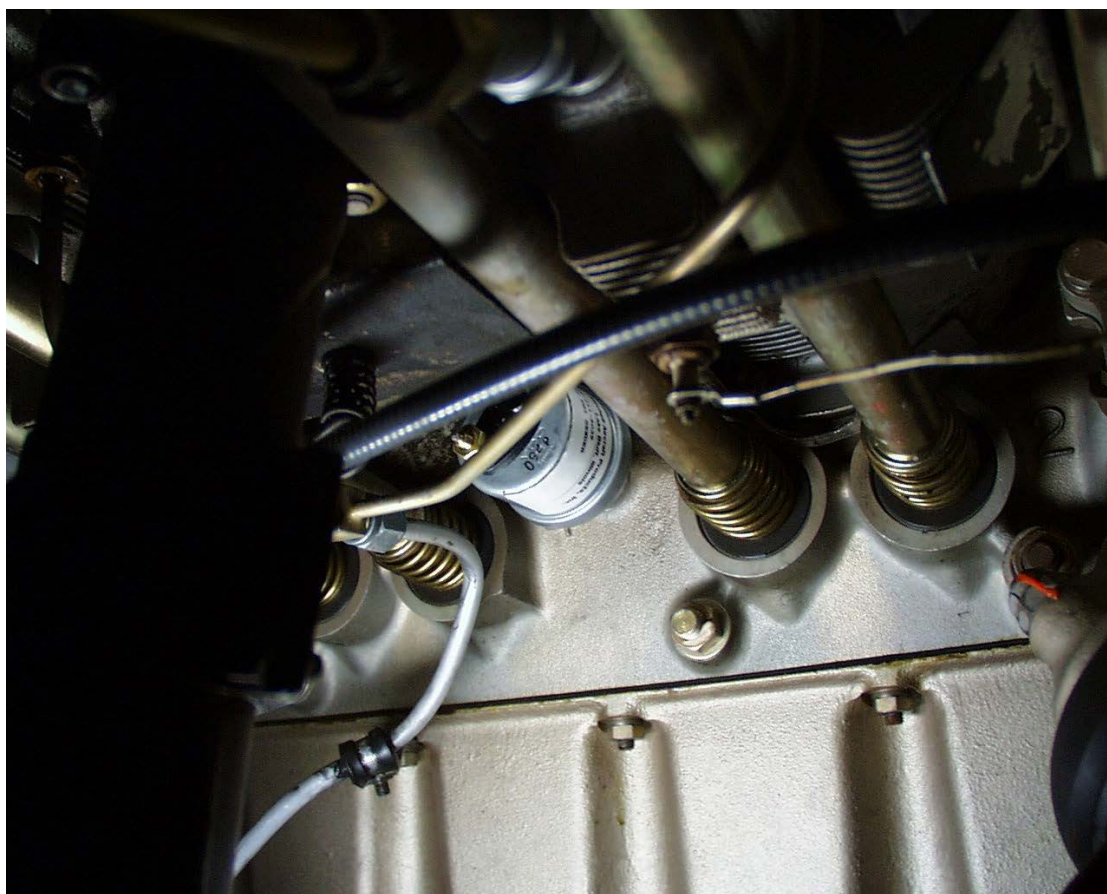
Figure 2 – Rear Engine Oil Pressure Transmitter (Mitchell P/N PS-211-9039)

3. Removed oil pressure line at rear engine and installed Mitchell oil pressure sending unit, p/n PS-211-9039, rated 0 to 100 psi. The new sending unit fit directly into the existing hole. The existing oil line was capped at both ends using an AN9293D cap assembly, and secured. See figure 2 for rear engine sending unit installation. A wire, p/n M22759/16-18, was installed from sending unit to gauge, using the existing wire bundle, routed through the center of the aircraft, just under the floor panels, running fore and aft; and secured with the existing clamps and ty-wraps. A connector, p/n RB14-8X was used to attach the wire to the sending unit. Routing, lacing, and tying comply with AC43.13-1A, Chapter 11, Section 7. Wiring marking complies with Section 4. Electronic equipment complies with the aircraft and equipment manufacturer's instructions and AC43.13-2A, Chapter 2, Paragraph 21 through 26.

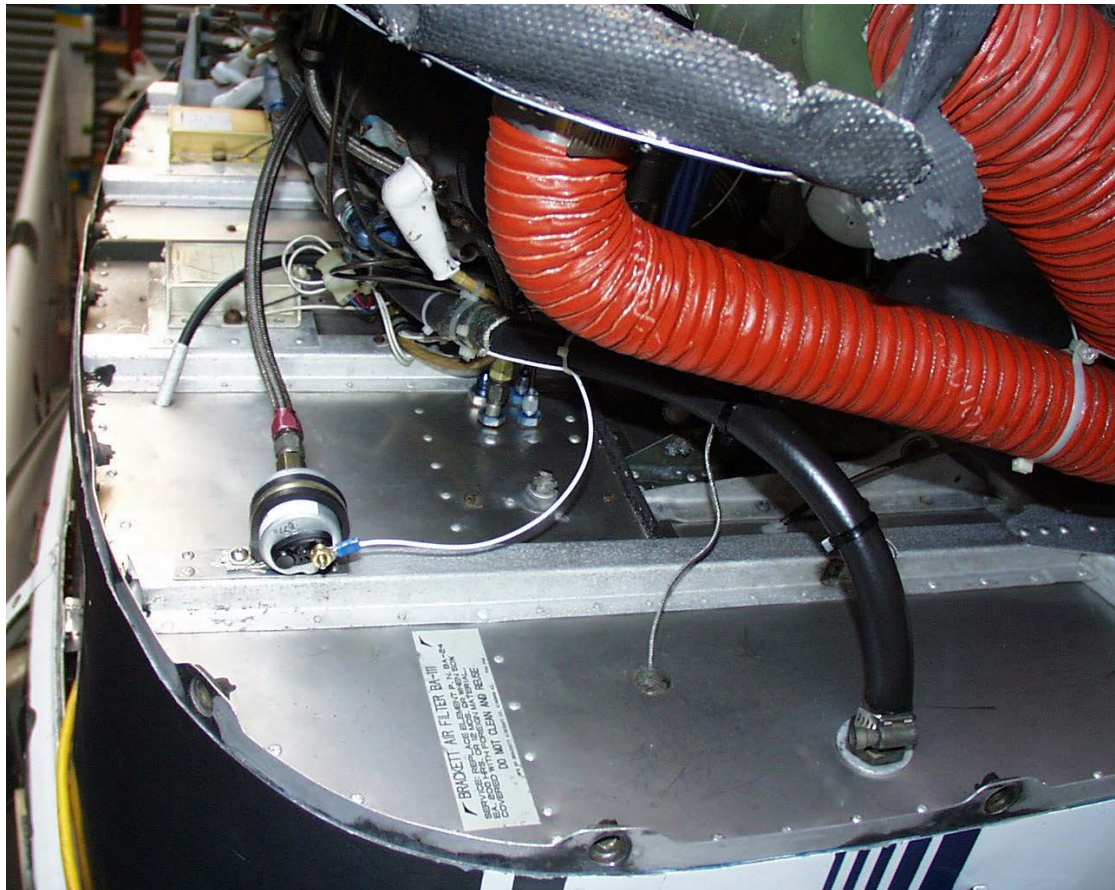
Figure 3 – Front Engine Oil Pressure Transmitter (Mitchell P/N PS-211-9029)

4. Removed forward engine oil pressure line at forward bulkhead fitting in engine compartment. Fabricated mount for forward oil pressure sending unit, p/n PS-211-9039, to be located on right side of forward bulkhead, in engine compartment. Mount was constructed of 2024-T3, .040 aluminum, ¾" by 3". A two lug nutplate, p/n MS21069L08, was fitted to the mount, which was then mounted to the firewall vertical channel with four #3 CherryMax rivets, p/n CR3523-3-2. The sending unit was then mounted in an Adel clamp, p/n MS2191DG24, using a fillister head screw, p/n MS35265-46. A 2 ½" length of braided bonding strap was incorporated with the clamp and secured with the said screw, to provide the necessary ground. An AN894 adapter was then installed on sending unit, to adapt the 1/8" pipe thread of sender unit to the original flared fitting, on the original section of oil line. See figure 3 for forward oil pressure sending unit installation. The wire, p/n M22759/16-18, was installed from sending unit to gauge. A connector, p/n RB14-8X, was used to connect the wire to the sending unit. An existing wire bundle was used to route the wire through the bulkhead, using existing ty-wraps and clamps.

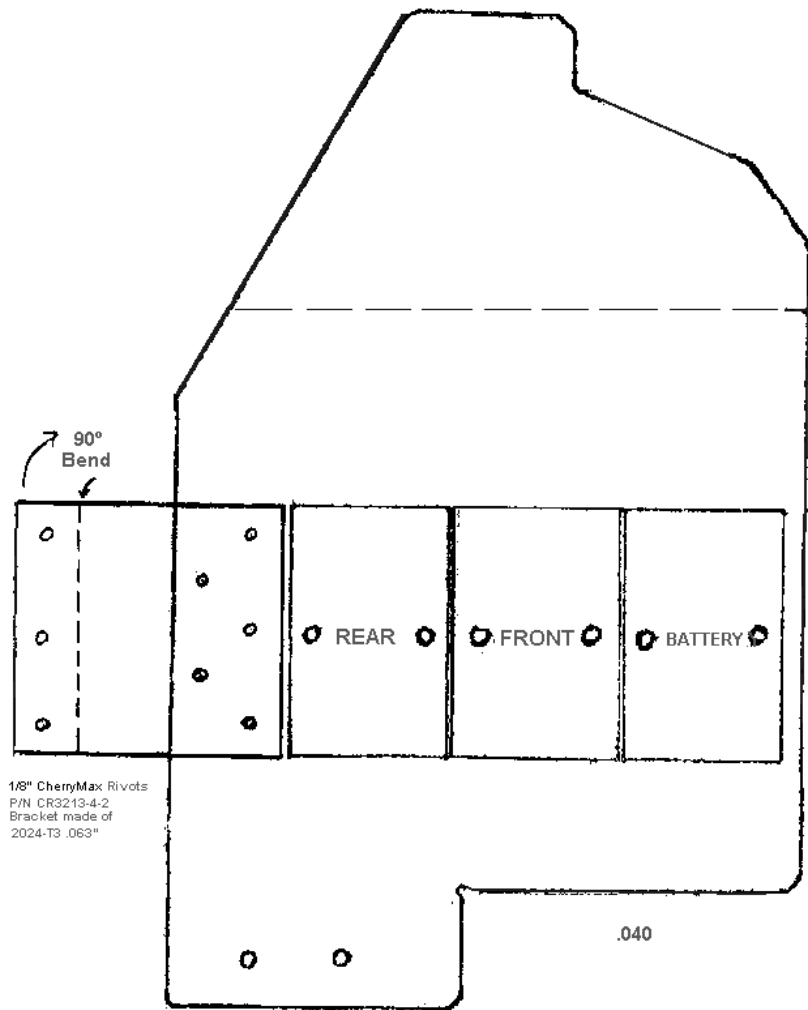
Fig.4-2024-T3 .040 Sheet Metal Shunt Mounting Base with Stiffner Bracket.

6. Removed original ammeter shunt support, p/n 1570044-1 and the three ammeter shunts, p/n 1570046-1. A new mount was fabricated from 2024-T3, .040 aluminum. The three new shunts, p/n PS2-9100, were then mounted to the new mount using MS-35207-264 screws and AN310-3 nuts. See figure 6, which is shown in actual size, for mount assembly and shunt placement. The assembly was then mounted in the original location. A stiffener, fabricated out of 2024-T3, .063 aluminum, was added, using eight cherry rivets, p/n CR3223-4-2. Three rivets attach the stiffener to the stringer and five fasteners attach the stiffener to the shunt support. See figure 4.

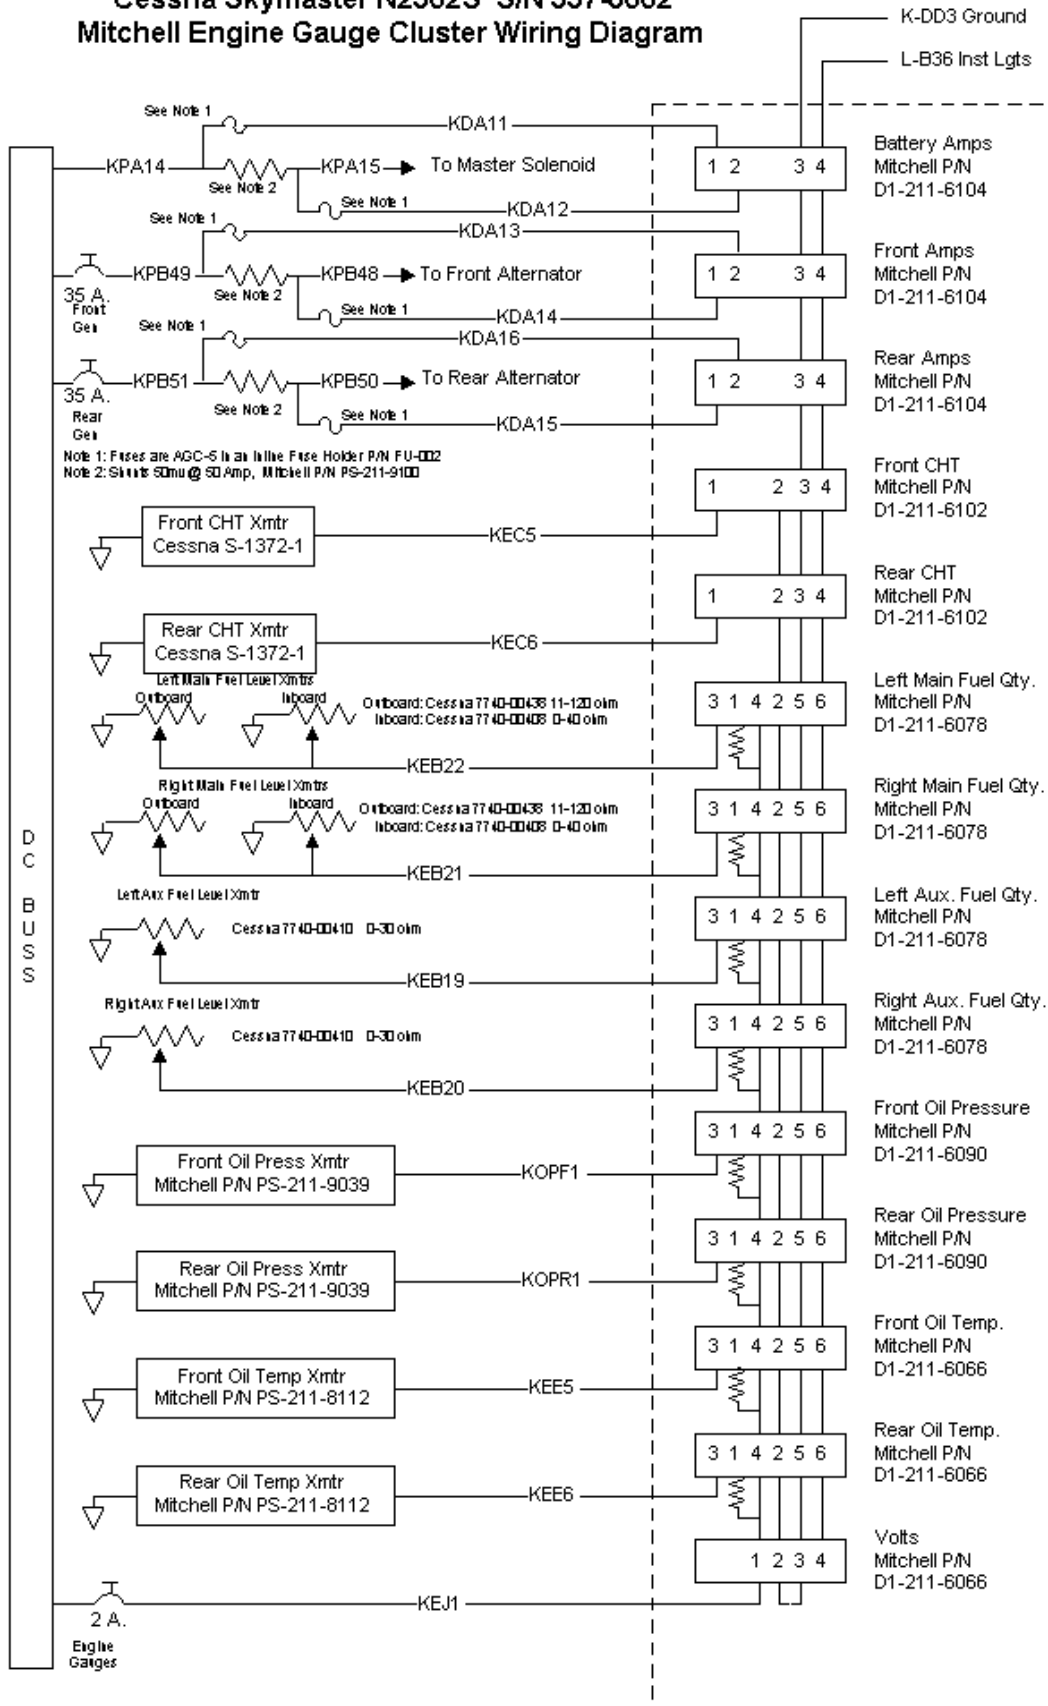
Figure 6. Engine Gauge Cluster Wiring Diagram.

7. Shunts were then wired in accordance with wiring diagram. See figure 6. The front alternator/rear alternator/battery rotary selector switch was removed from the instrument panel, and a blanking plate installed in its location. Original wires were utilized except for wires K-PB49 and K-PB51, since the difference in the shunt size made the original wires too short. The wire used was p/n MS22759/18-8, as indicated on figure 5. The addition of individual gauges allows independent and full time monitoring of battery current and each alternator load, negating the need for the original rotary selector switch.

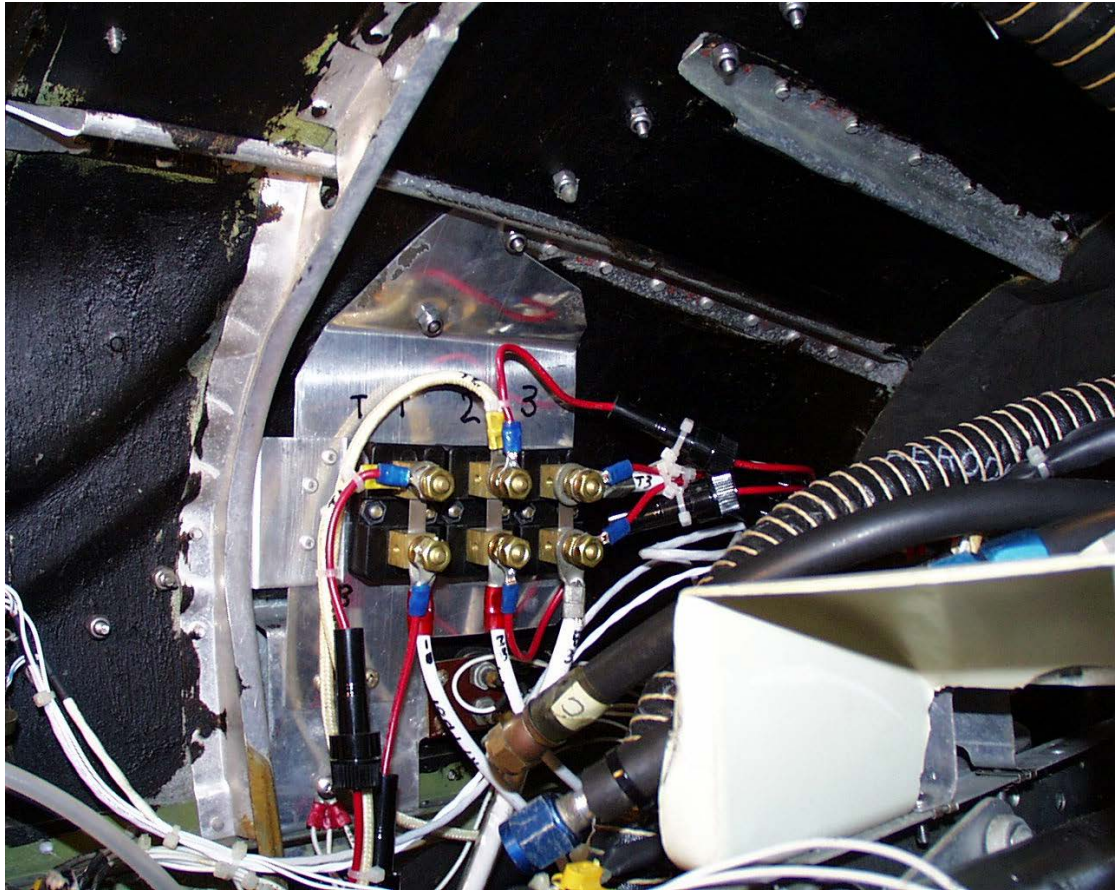
Fig. 7 – Installed Shunts.

8. An insulating curtain was fabricated to protect the shunts by bending a 6" by 1 1/4" piece of 2024-T3, .063 aluminum into an "L", and safety wiring two 3" by 6" pieces of Mil Spec ZZR765B Silicone rubber sheet to "L" bracket. This assembly was then attached to the airframe by utilizing existing hardware, as shown in figures 7 and 8.
