# THE C-336 SKYMASTER STORY

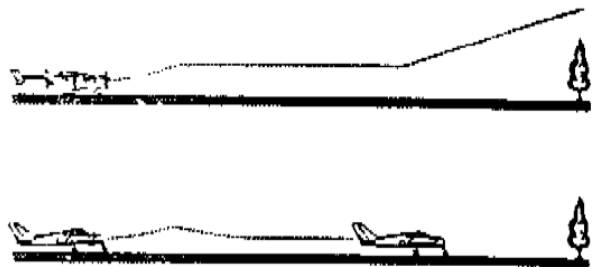
Fig. 7 - Take-off profile with engine cut at 1.1  $V_5$

In comparing the last two take-off profiles, one can see that the CLT twin’s engine-out take-off distance advantage is amplified as the airspeed at engine cut is reduced from 1.2 Vs to 1.1 Vs in this case the conventional twin has no alternative but to discontinue the take-off because the engine cut occurs at an airspeed lower than minimum control speed (Vmc). In contrast, the CLT airplane is able to continue with the take-off since its Vx speed is very close to the 1.1 Vs speed. These comparisons are illustrated convincingly in Figure 8, showing numerical distances as a function of engine-out speed.
